Insulation System Reliability in Wind Generation

Howard W Penrose, Ph.D., CMRP
SUCCESS by DESIGN
Lombard, Illinois, USA
howard@motordoc.com

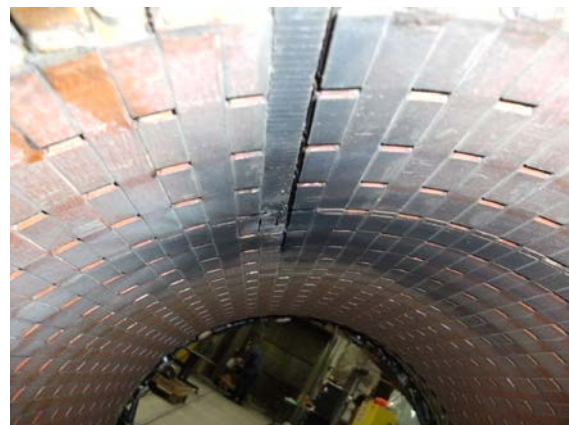
The initial observation identified a common symptom of the stator winding failures associated with both DFIG and IG machines and similar between the two rotor winding failures of the DFIG. The failures were all coil to ground at the top of the slot and associated magnetic wedge material was missing from the slot. There were also several conditions that went along with these machines. In some cases, only the wedge associated with the winding failure was missing, in other cases, a large number of wedges were missing, including the area where the coil failed. In all cases, the wedge material was missing where the coil failed as shown in Fig 1.

Fig. 1. Failed Stator Coil with Missing Wedge

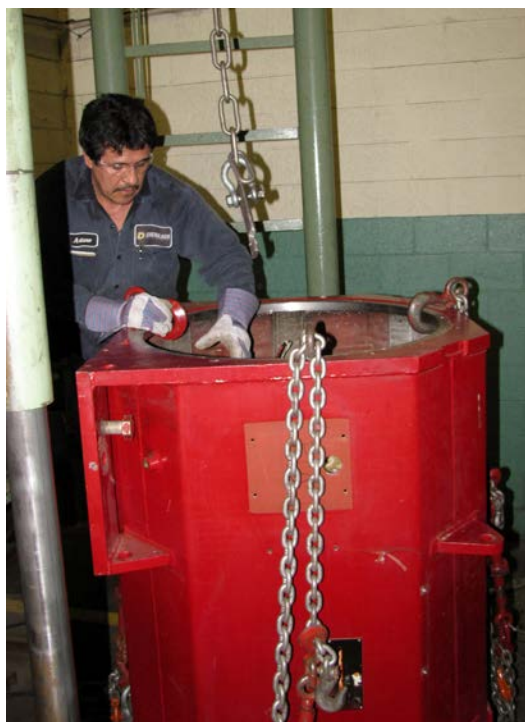
the stator or rotor is placed in a burnout oven and the insulation material is incinerated off of the copper. The root-cause-analysis covered in this paper utilized a stator warming process which allowed the intact removal of the stator windings enabling a full investigation of the insulation system as shown in Fig. 2.

Fig. 2. Stripping Generator Vertically

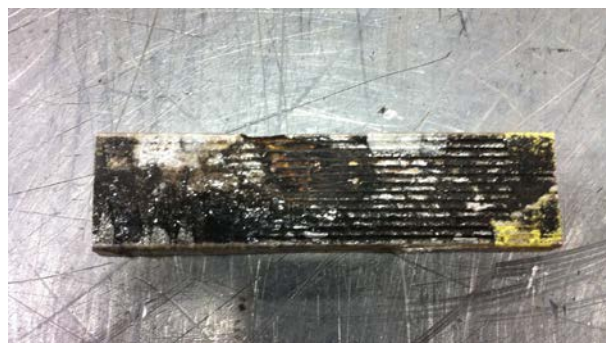
Fig. 3. Inspection of a section of failed coil after tape removal showing surface damage on conductors only indicating ground fault

As shown in Fig. 3., all of the coils were found to have failed to ground versus turn to turn shorts. The potential causes that were investigated on each machine included:

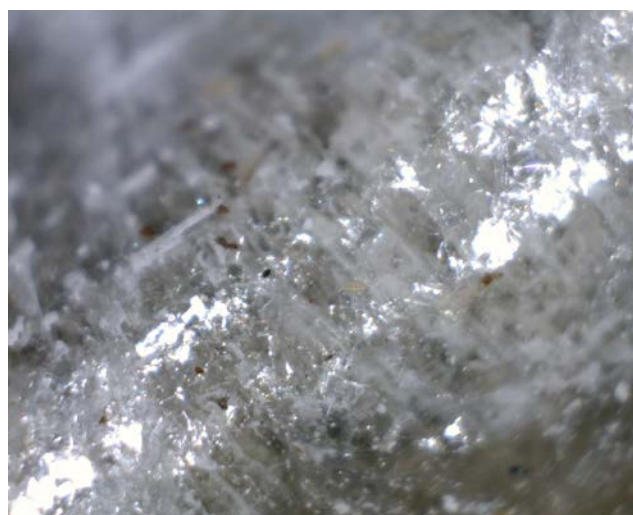
Sections of good and bad coils were made and the material peeled back layer by layer and inspected by microscope. The small brownish objects shown in Fig. 4. are iron particles that have 'tunneled' their way into the insulation system. This symptom tended to be found along the top edge of coils where the wedges were missing and magnetic wedge iron dust had gathered.

Fig. 4. Iron filings and pathways several layers deep into mica tape along top edge of top coil.

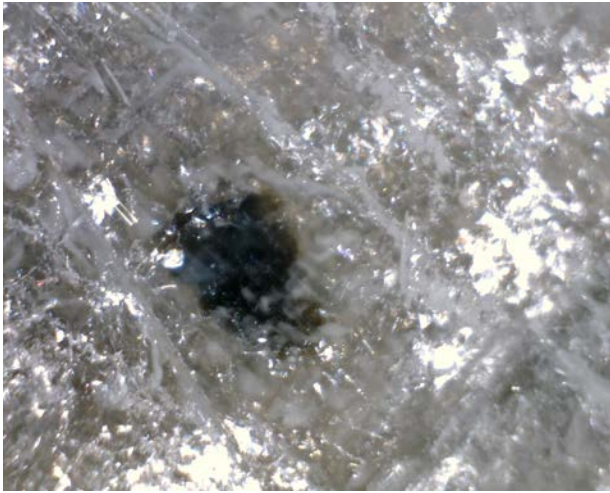
During a period of time in operation as the generator cycles, in particular in times of thermal extremes, the insulation system begins to release. Forces on the coils are radial against the spongier packing materials and the material begins to compact, increasing the forces acting against the wedges. Eventually one or more wedges break loose from the slot either due to the brittleness of the wedge or the wedge acting against the wedge slot wears it open. The wedge drags on the rotor causing iron particulate to spread throughout the generator and some to gather in the open top of slot against the direction of rotation. The iron begins to drill its way into the insulation system eventually creating a path to ground or allowing electrical sparking and insulation degradation (Fig. 5.).

Fig. 5. Arcing point in armor tape resulting in burned mica tape.

In order to break a chain of events, a link in the chain must be broken. In this case, there are two options for lengthening the life of a wind generation machine. The first one involves replacing the magnetic wedges with a different wedge material. However, the benefits of using magnetic wedges are lost. Keeping the magnetic wedge but improving coil and packing materials may be a better solution.

The magnetic wedge is less likely to vibrate and fail if a constant tension is kept on it. This opens several solutions that can be implemented both on the new manufacture and overhaul of an electric machine:

- Larger machines may have the opportunity to use ripple springs as side and top packing. This provides the additional benefit of maintaining constant tension across significant temperature ranges. The stator may still be VPI'd with the use of ripple springs.
- Tighter top and side packing for smaller machines using solid materials such as Nomex®. This may mean that wedges will have to be manufactured in shorter sections versus one or two long wedges.
- Shorter wedges that conform better to the wedge slots in order to reduce the amount of wedge vibration.
